Observational Study of Final Cleaning and AHERA (Asbestos Hazard Emergency Response Act) Clearance Sampling at Asbestos-Abatement Sites in New Jersey

PEI Associates, Inc., Cincinnati, OH

Environmental Protection Agency, Cincinnati, OH

Aug 89

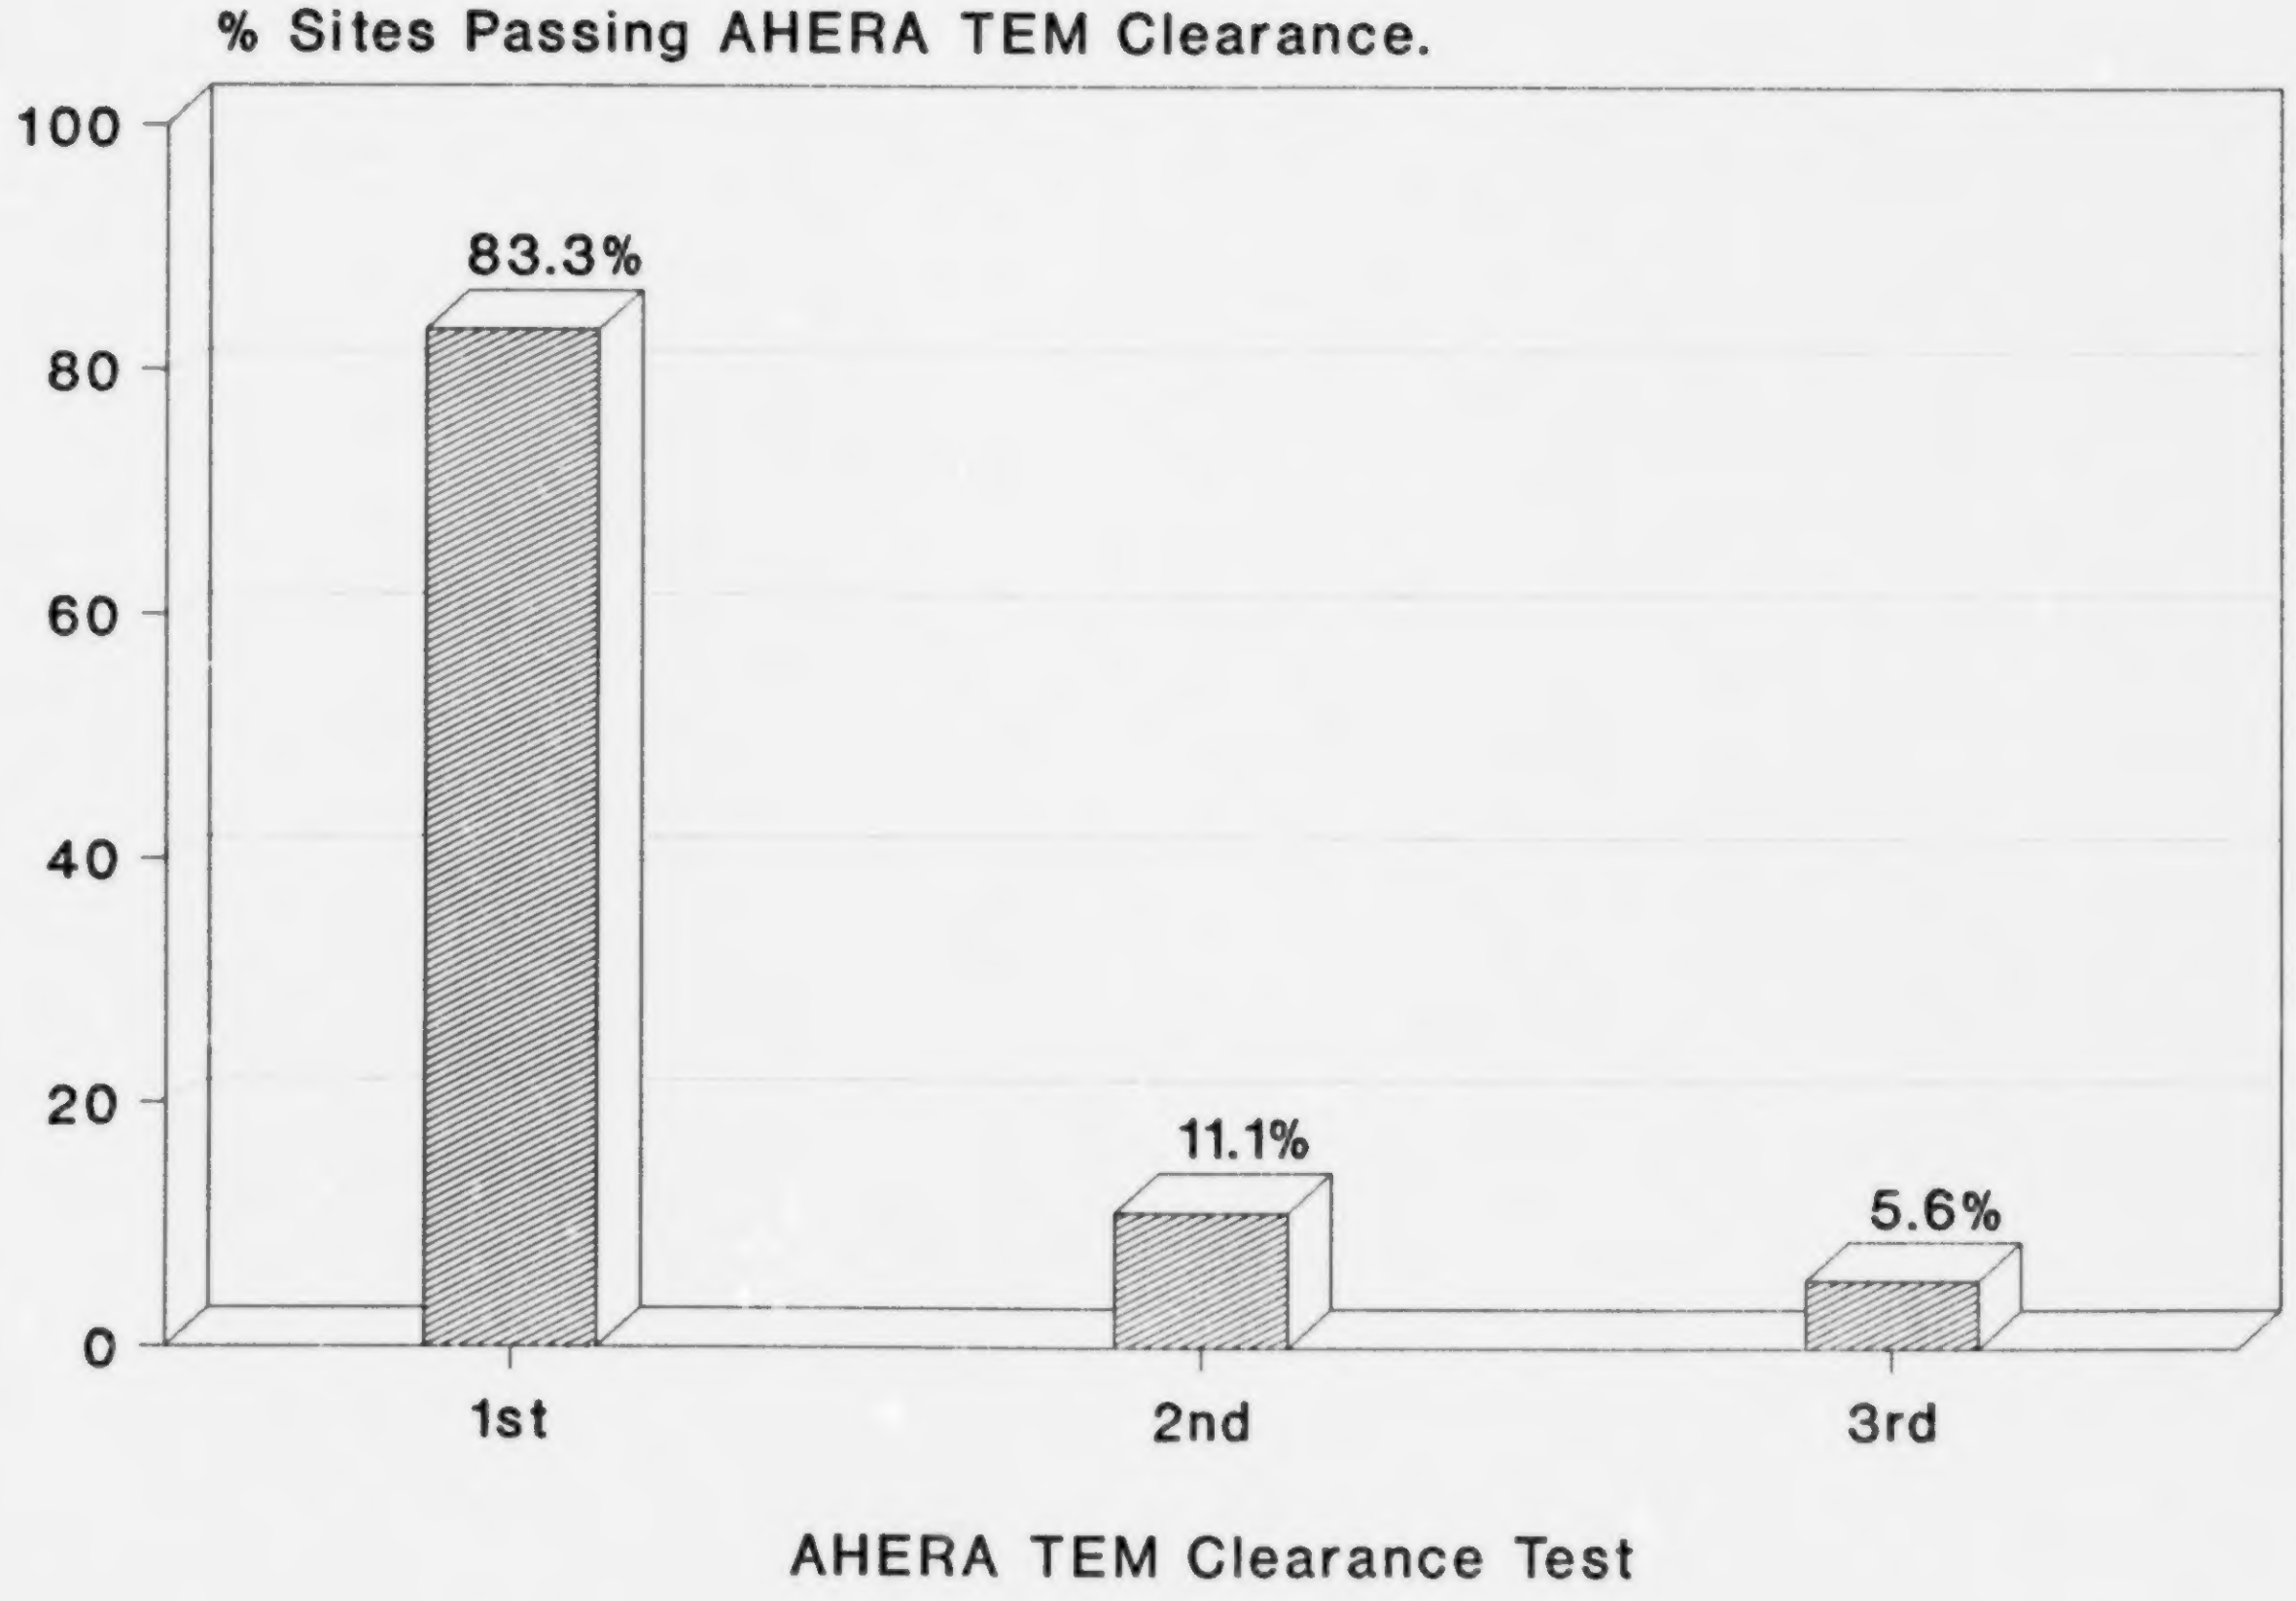
All of the 18 sites ultimately passed the AHERA TEM clearance criterion of the initial prescreening test (i.e., the average asbestos concentration of the samples collected inside the abatement area was less than or equal to 70 s/mm^2). Three sites initially failed the prescreening test, and two of

Figure 6. Percentage of 18 sites passing AHERA TEM clearance for each clearance attempt.

these sites subsequently tried to use the Z-Test to pass clearance. In each case, the site also failed the Z-Test and had to be recleaned. The Z-Test was used only twice at the 20 sites observed in this study, and it was never used to clear the abatement site. Figure 7 presents the average asbestos concentrations for each clearance attempt for the 18 sites that were cleared by TEM.

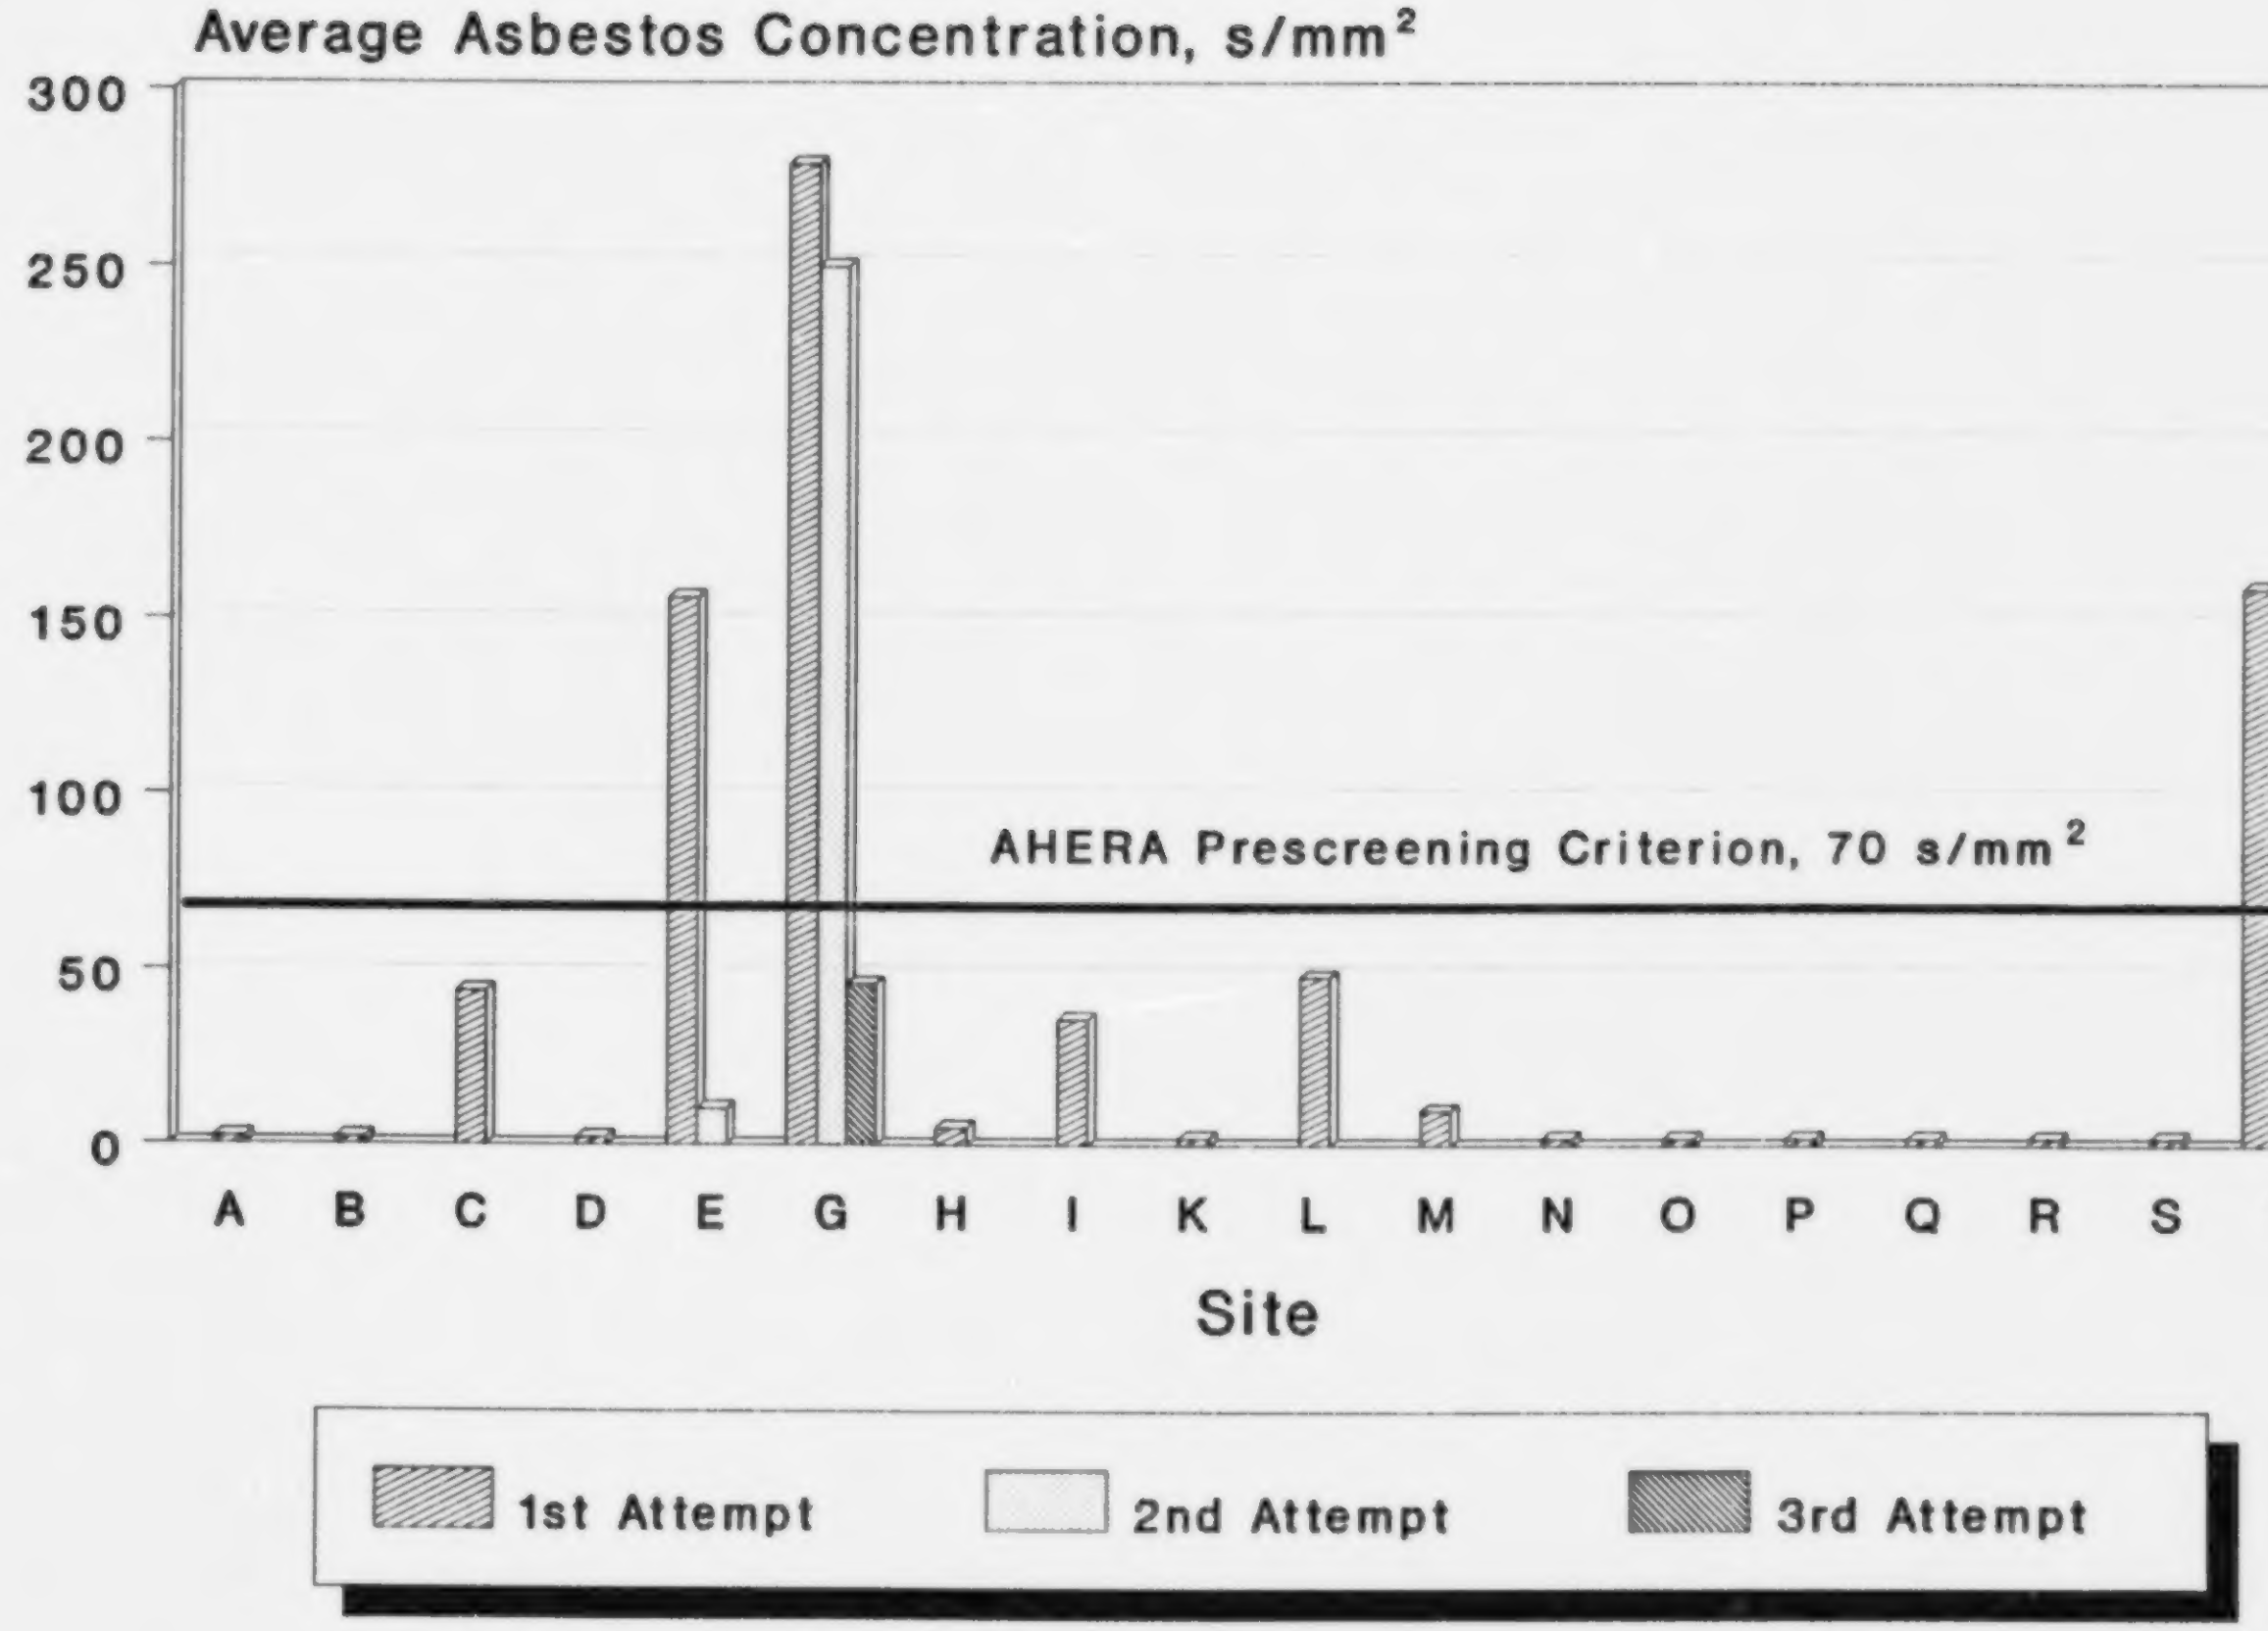
Figure 7. Average asbestos concentrations for each AHERA clearance attempt for the 18 sites cleared by TEM.

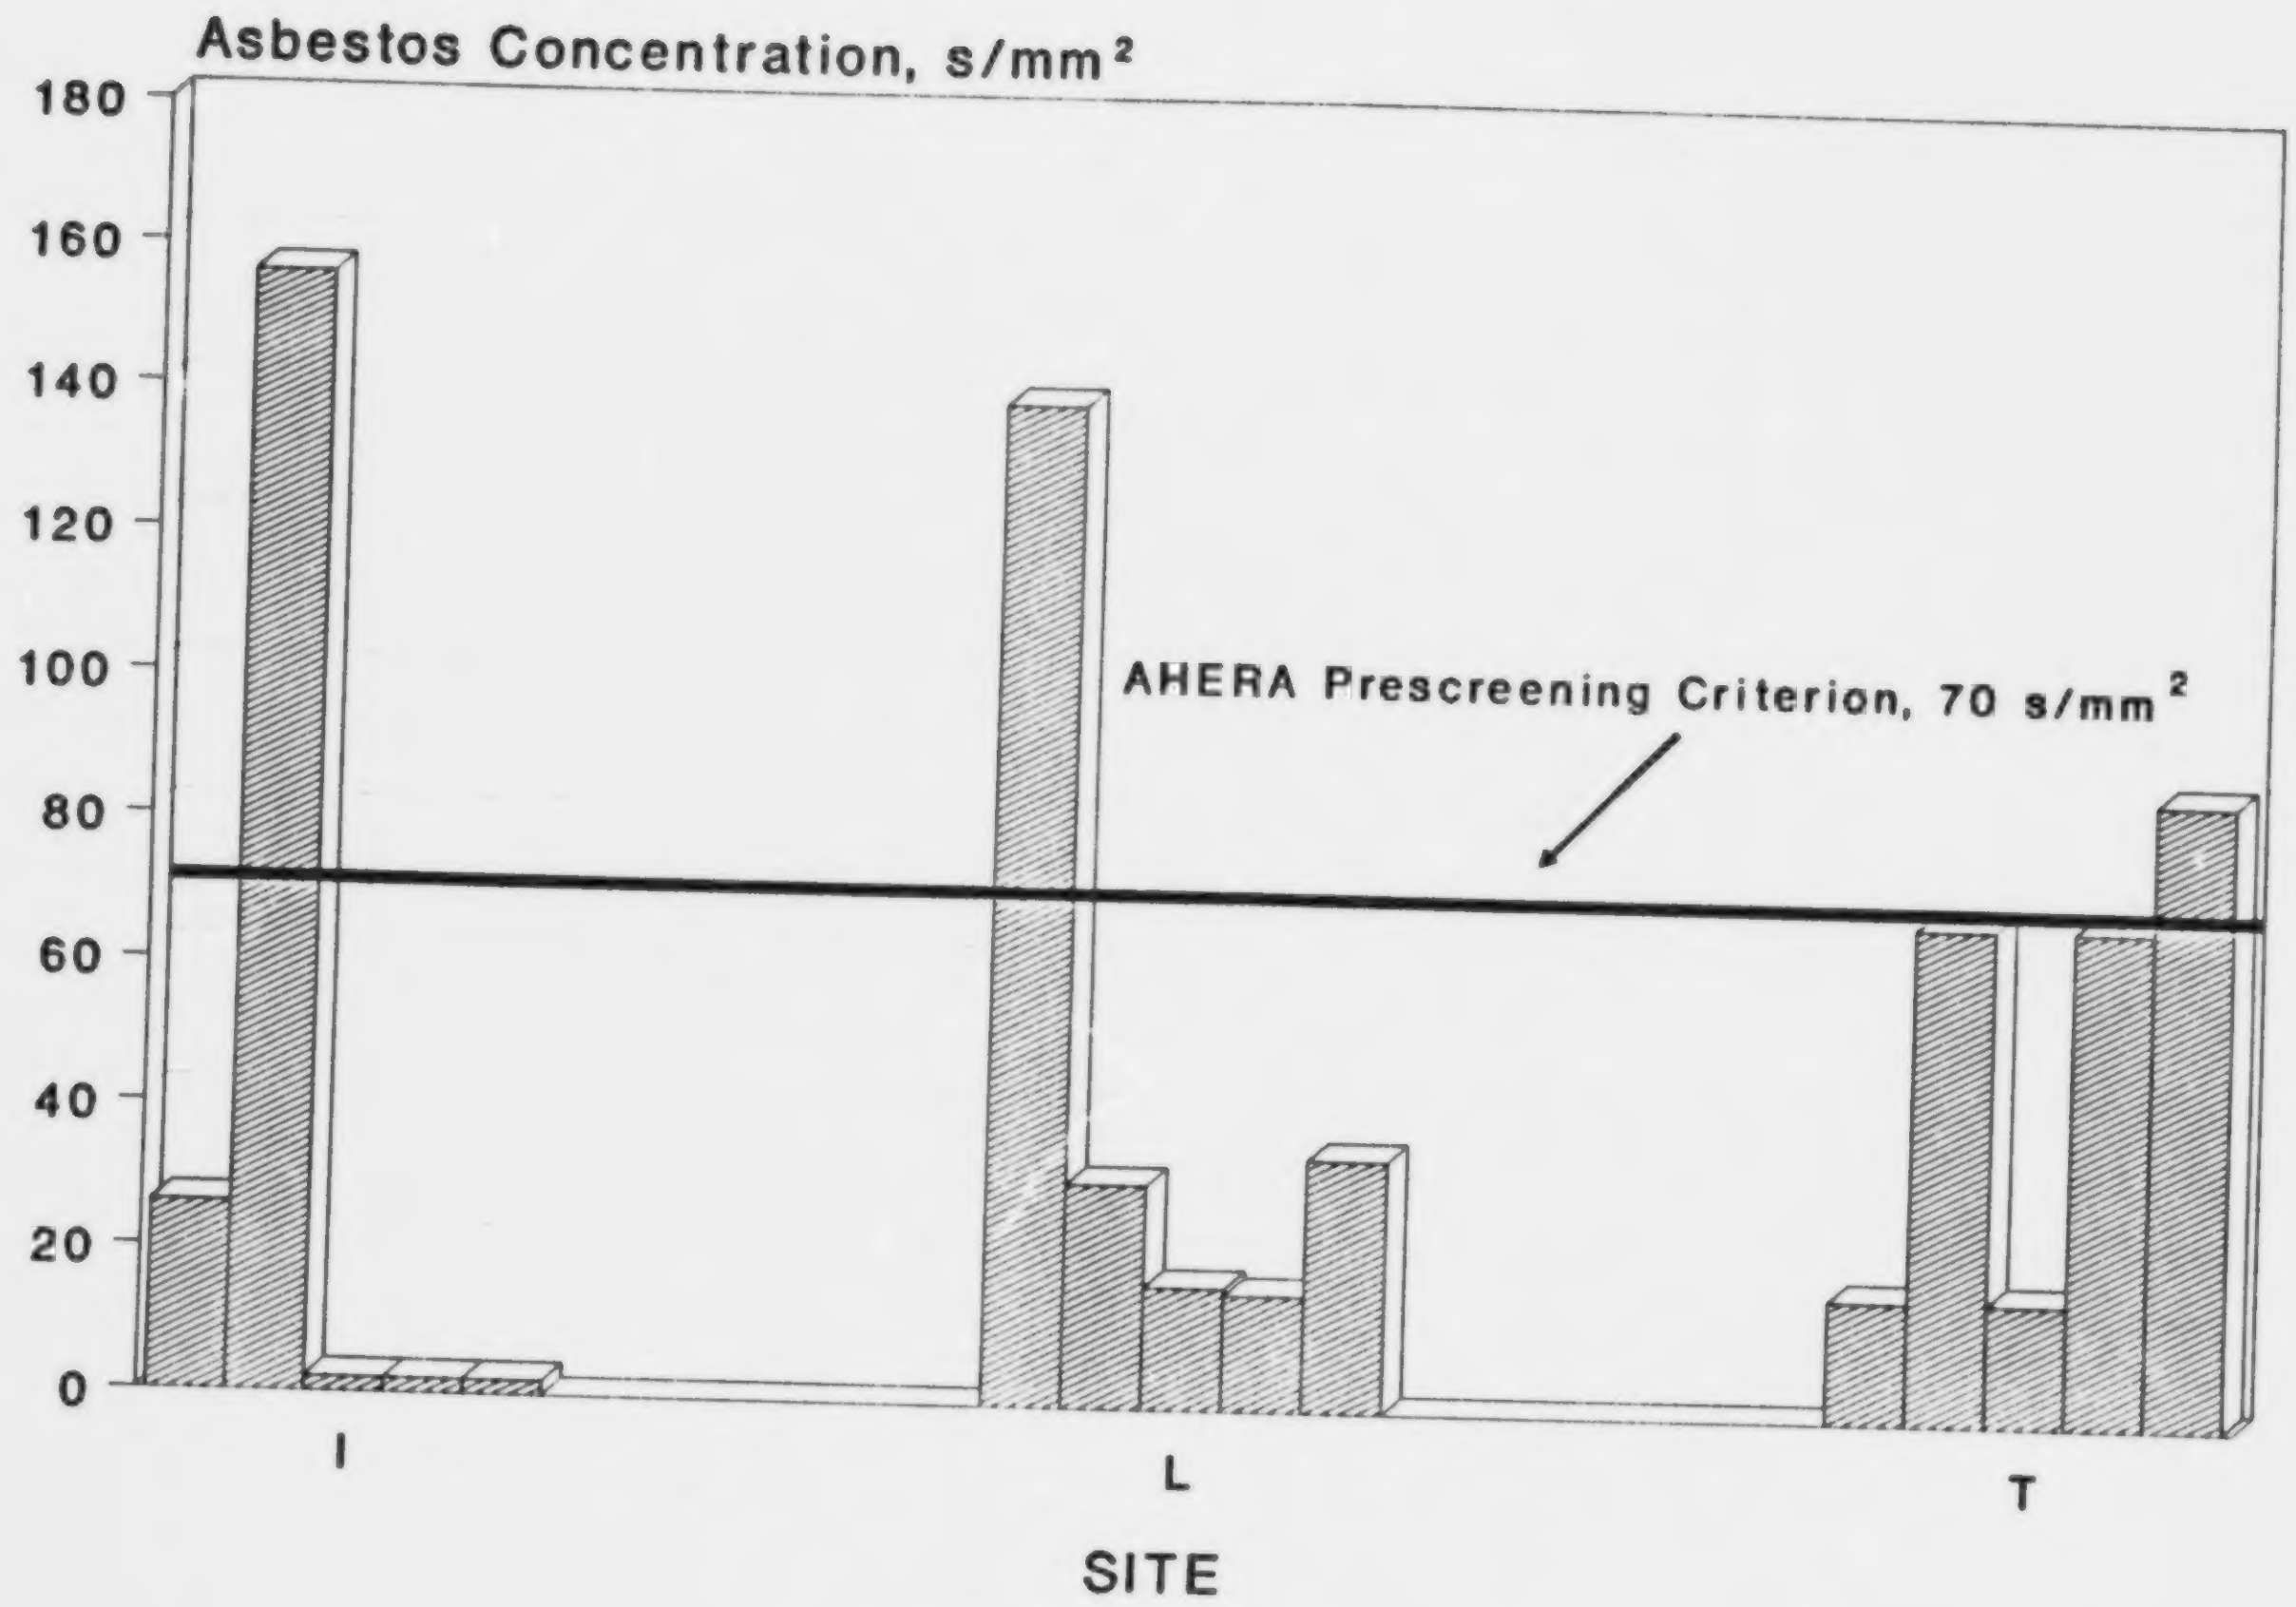
Figure 8. AHERA clearance results for sites with individual sample concentrations greater than 70 s/mm².

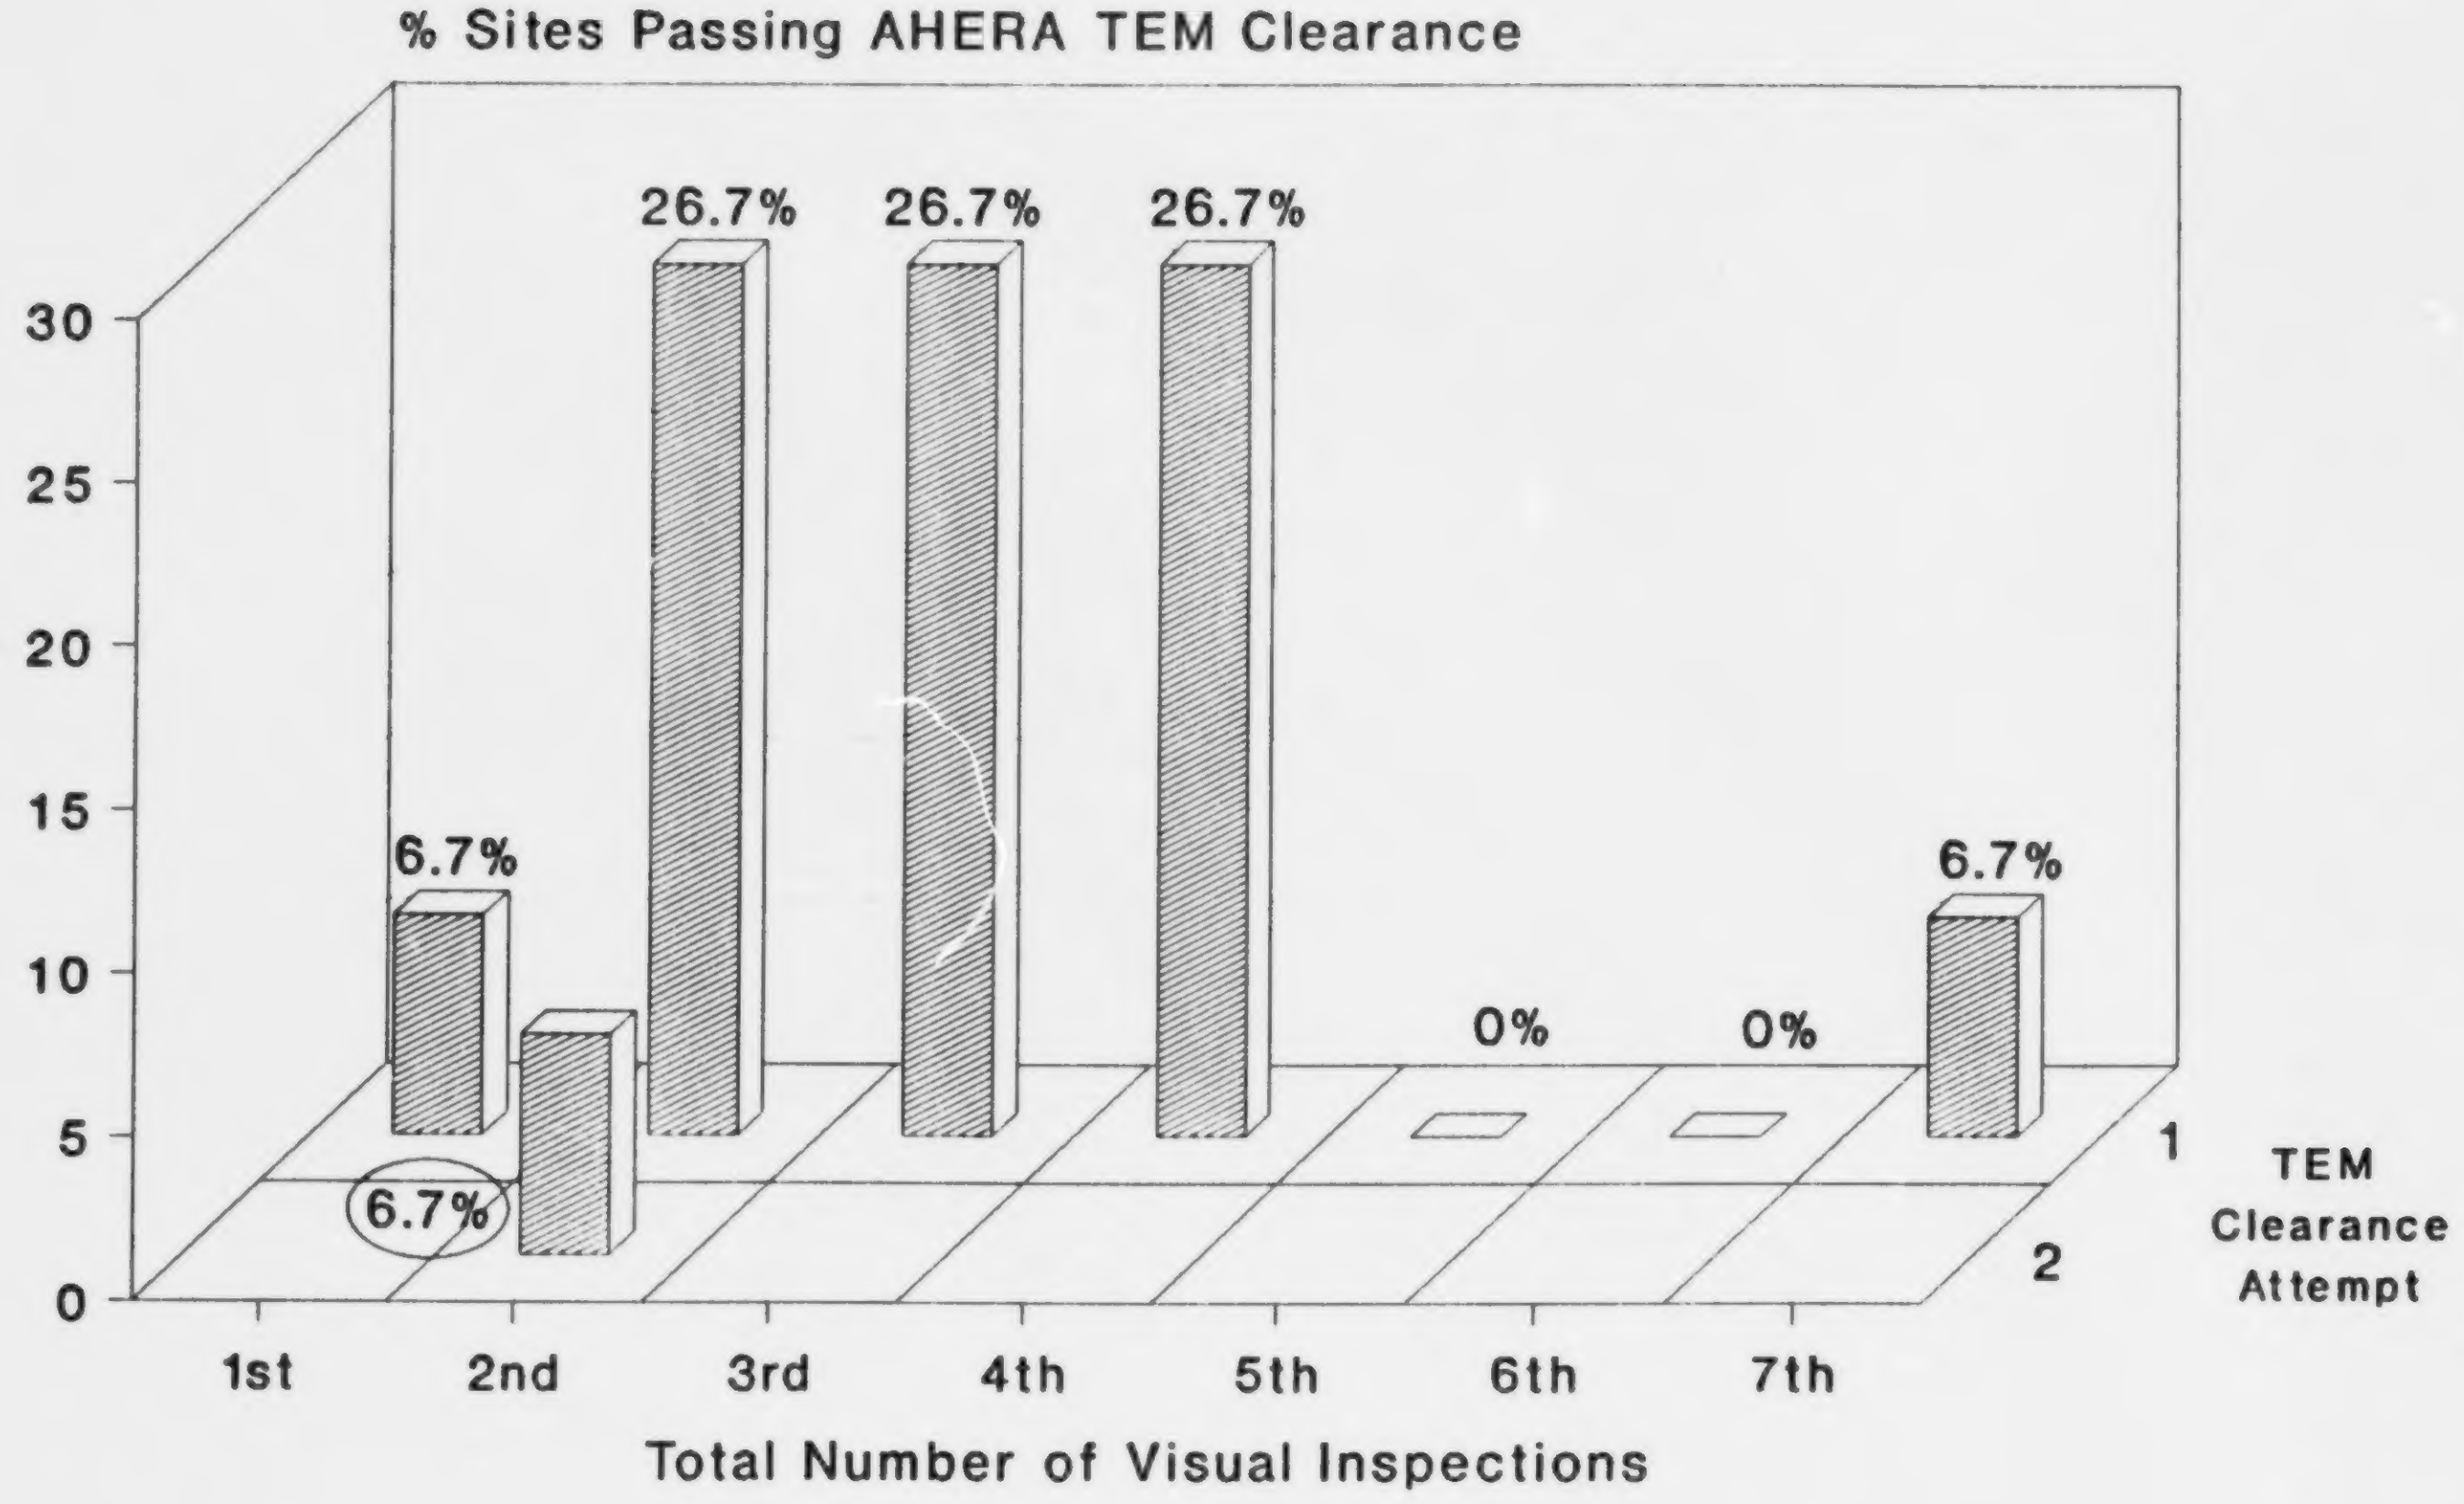
Figure 9. Percentage of 15 sites passing AHERA TEM clearance by total number of ACS visual inspections and AHERA clearance attempt.

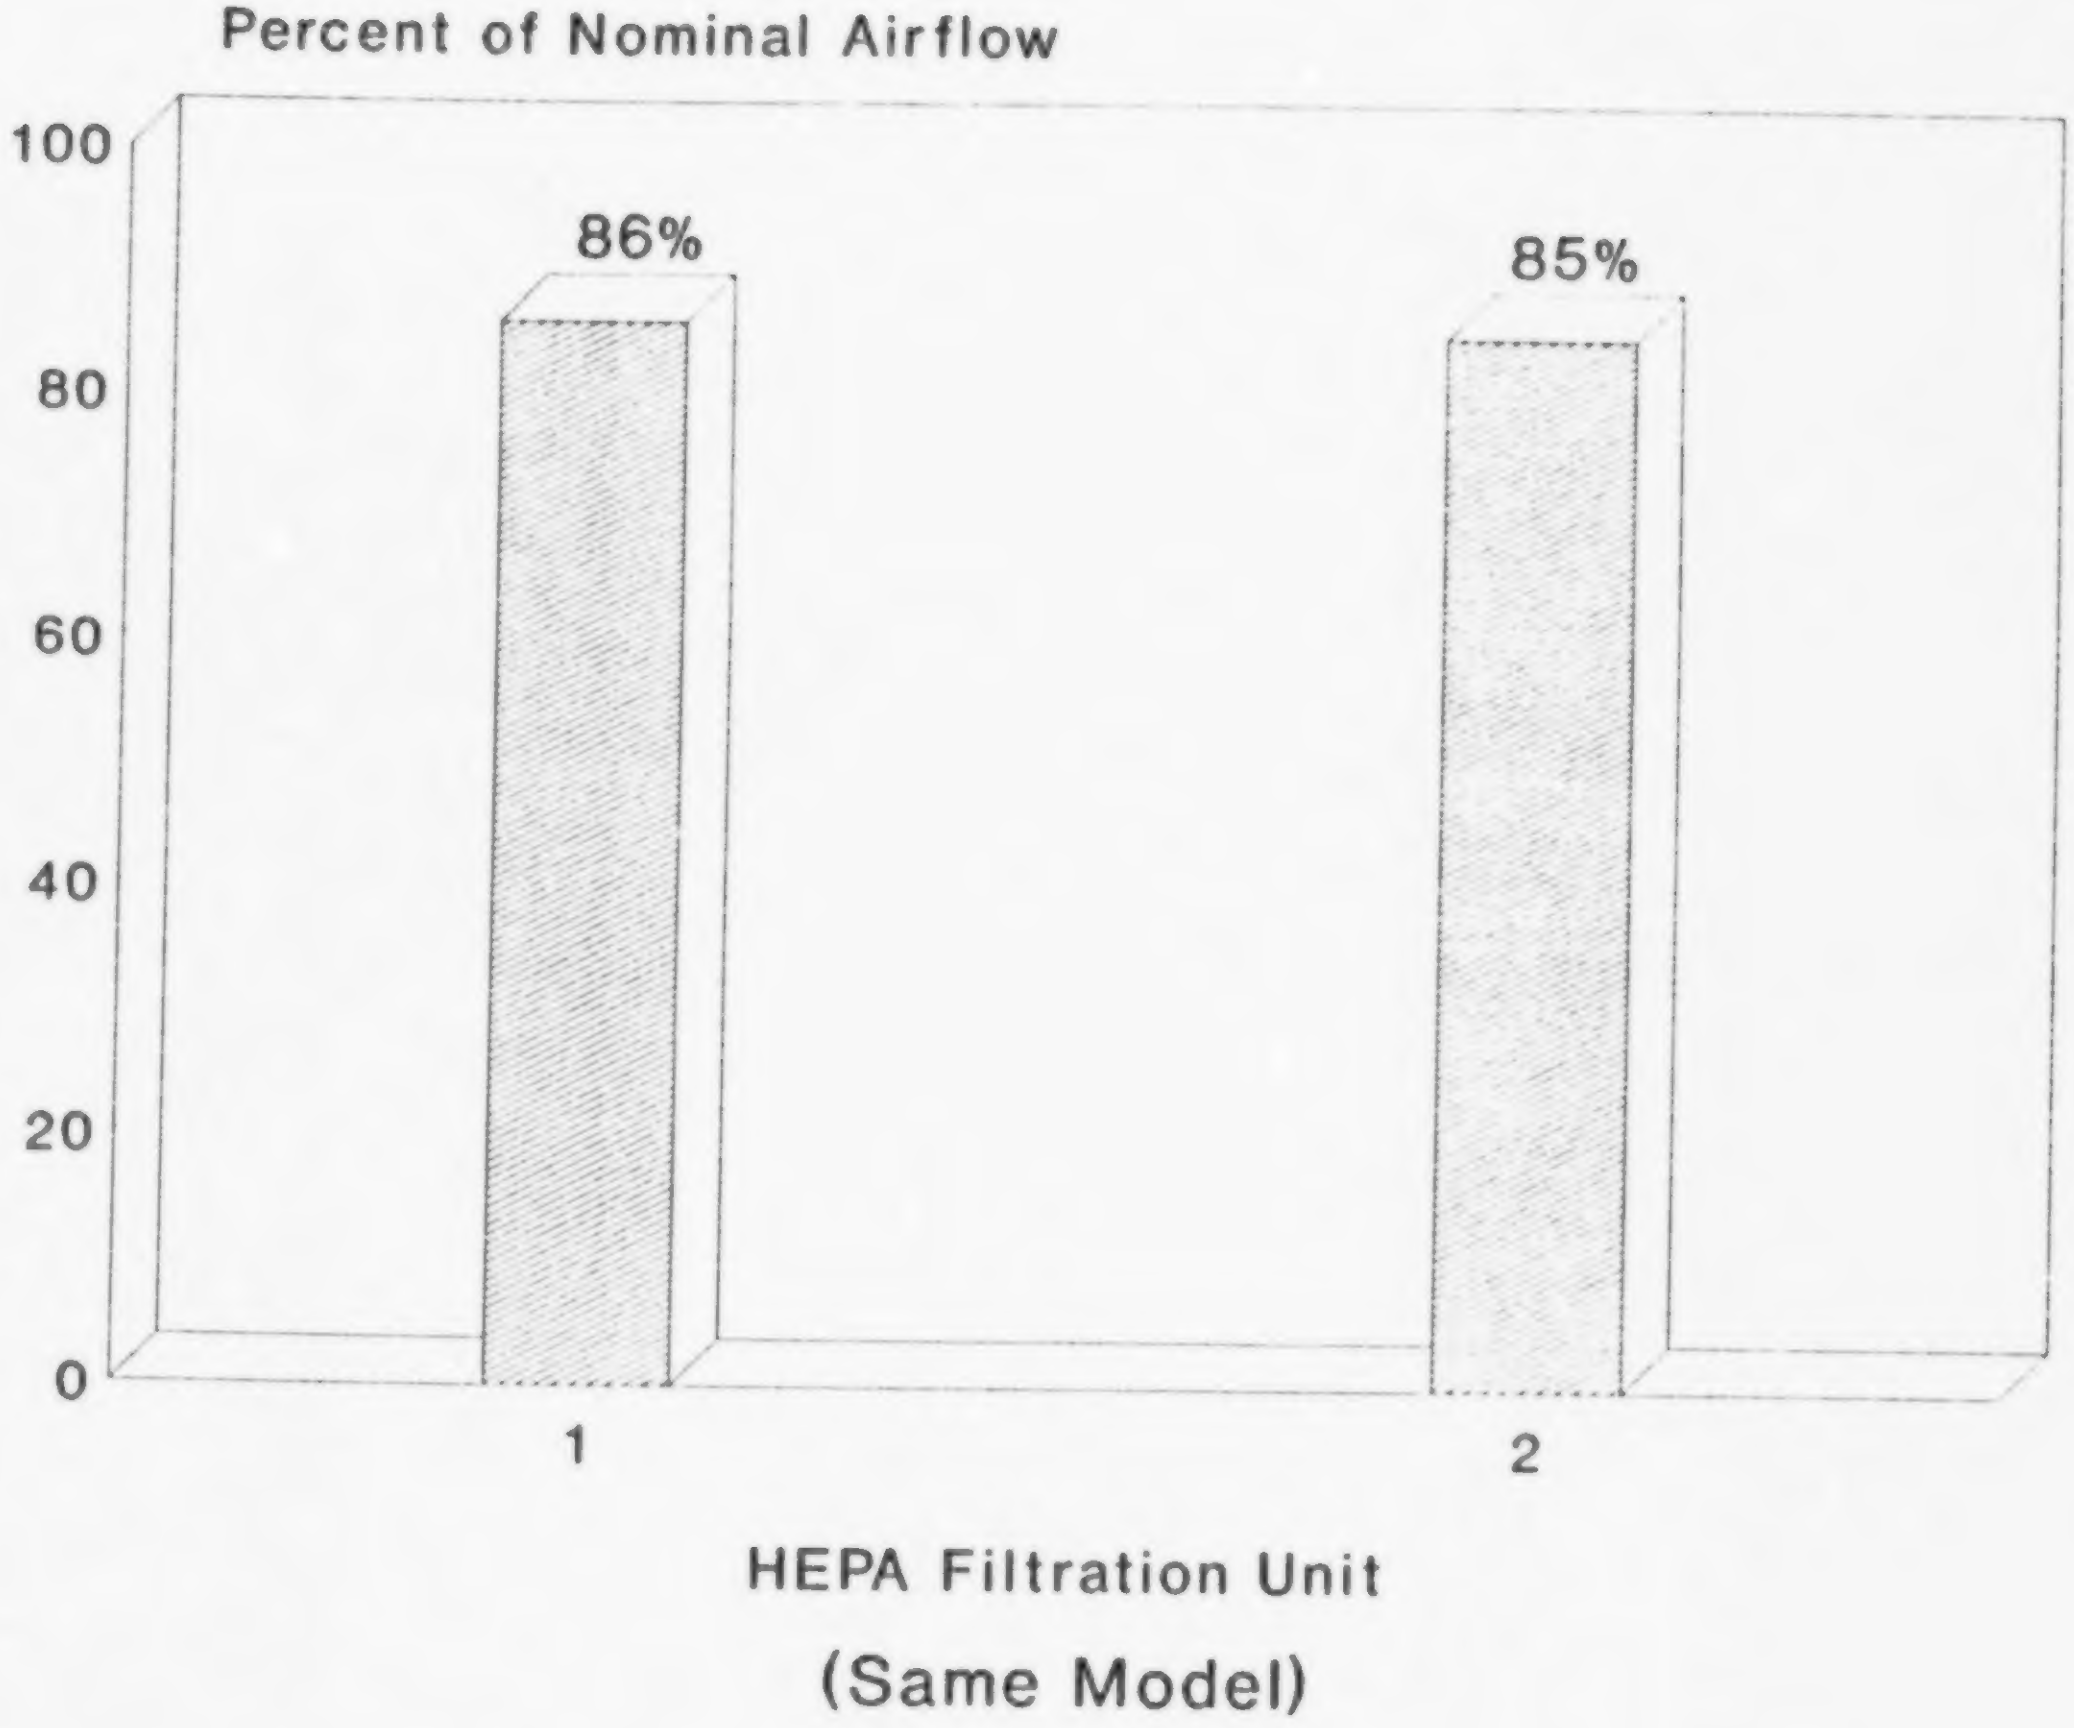
Figure B-1. Airflow performance for HEPA filtration systems operating during AHERA clearance.

Figure B-1 compares the measured air-intake volume of each HEPA-filtration unit operating during AHERA clearance sampling with the unit's nominal airflow. The actual operating percentages of the nominal air flow were 85 and 86 during AHERA clearance sampling.

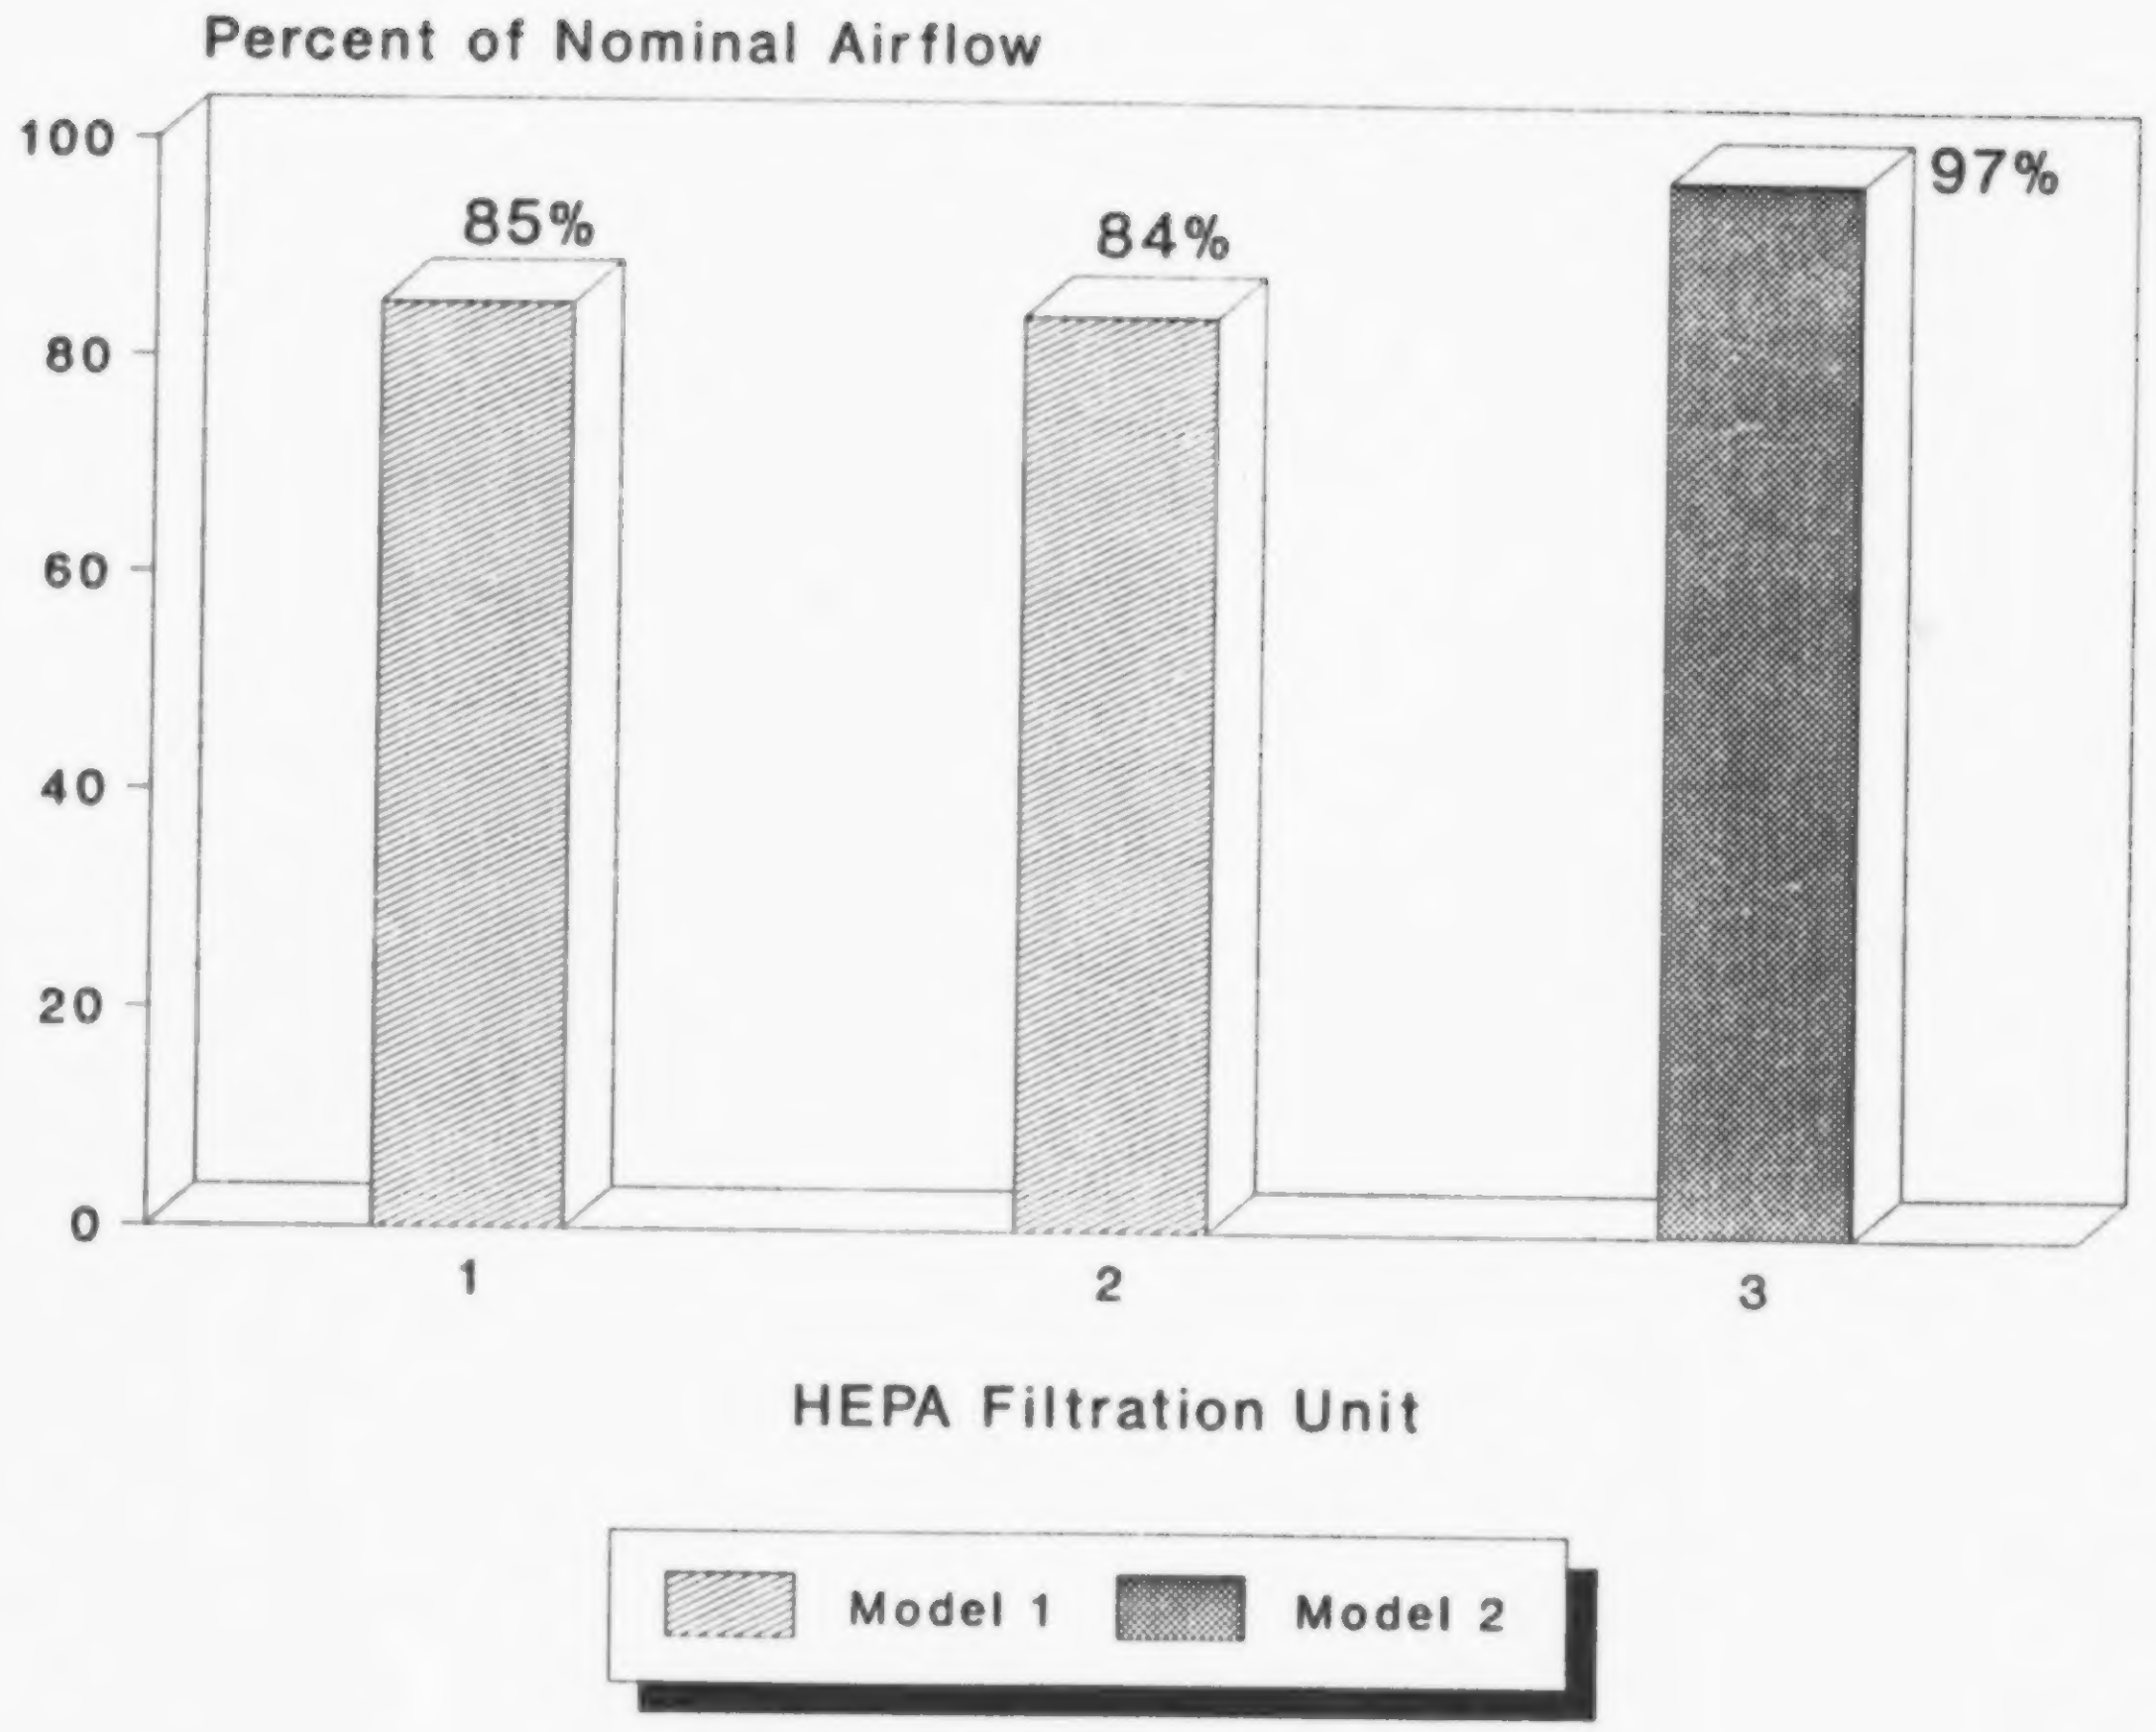
Figure D-1. Airflow performance for HEPA filtration systems operating during final cleanup.

Figures D-1 and D-2 compare the measured air-intake volume of each HEPA-filtration unit operating during final cleaning and AHERA clearance sampling, respectively, with the unit's nominal airflow. The actual operating percentages of the nominal airflow ranged from 84 to 97 during final cleaning and 79 to 99 during AHERA clearance sampling. The reason for the significantly higher operating airflow performance of the third air filtration unit is not known.
